Chian SC, Wilkinson SM. Feasibility of Remote Sensing for Multihazard Analysis of Landslides in Padang Pariaman during the 2009 Padang Earthquake. *Natural Hazards Review* 2015, 16(1), 05014004.

Landslides in Padang Pariaman during the 2009 Padang Earthquake: Field Survey and GIS Analysis

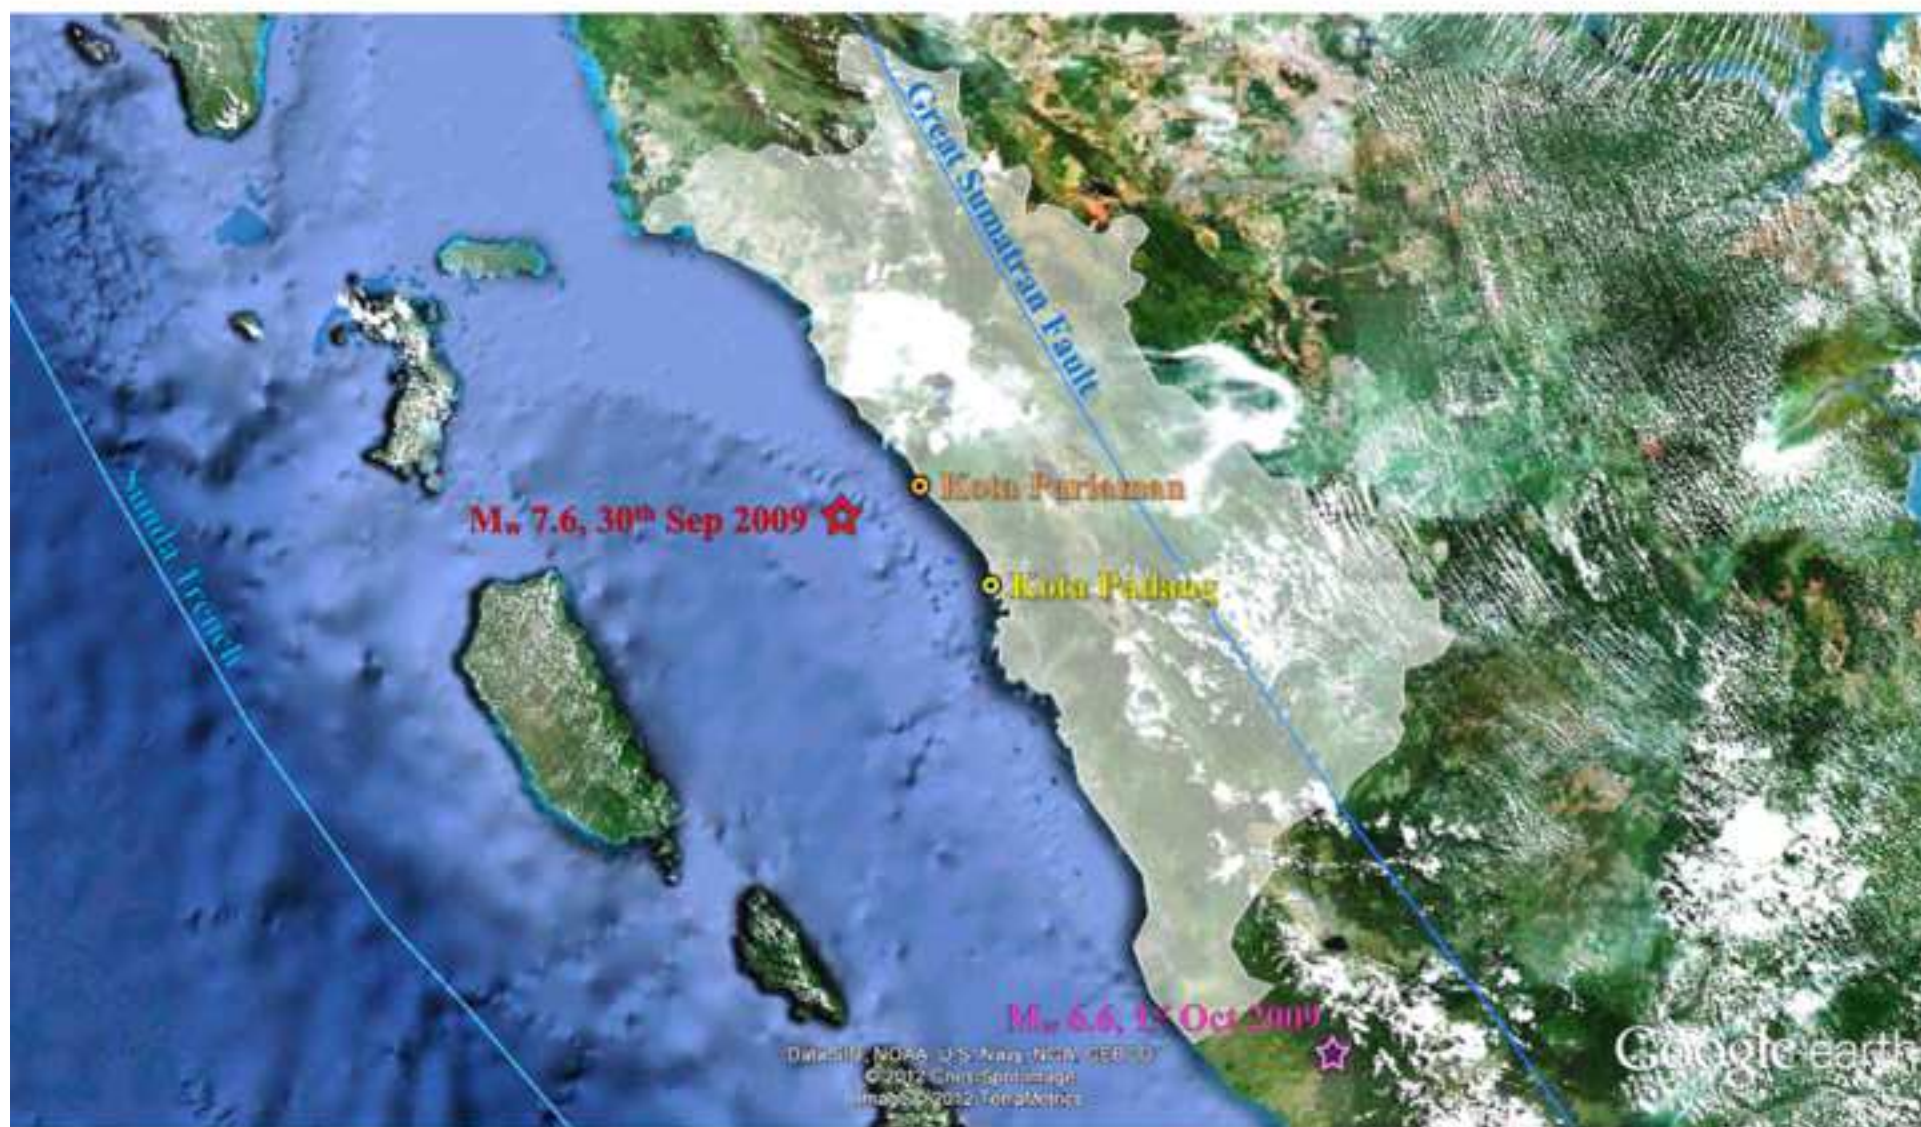
Figure 1
[Click here to download high resolution image](#)

Fig. 1 Locations of earthquake epicentres and fault lines plotted on Google™ Earth background

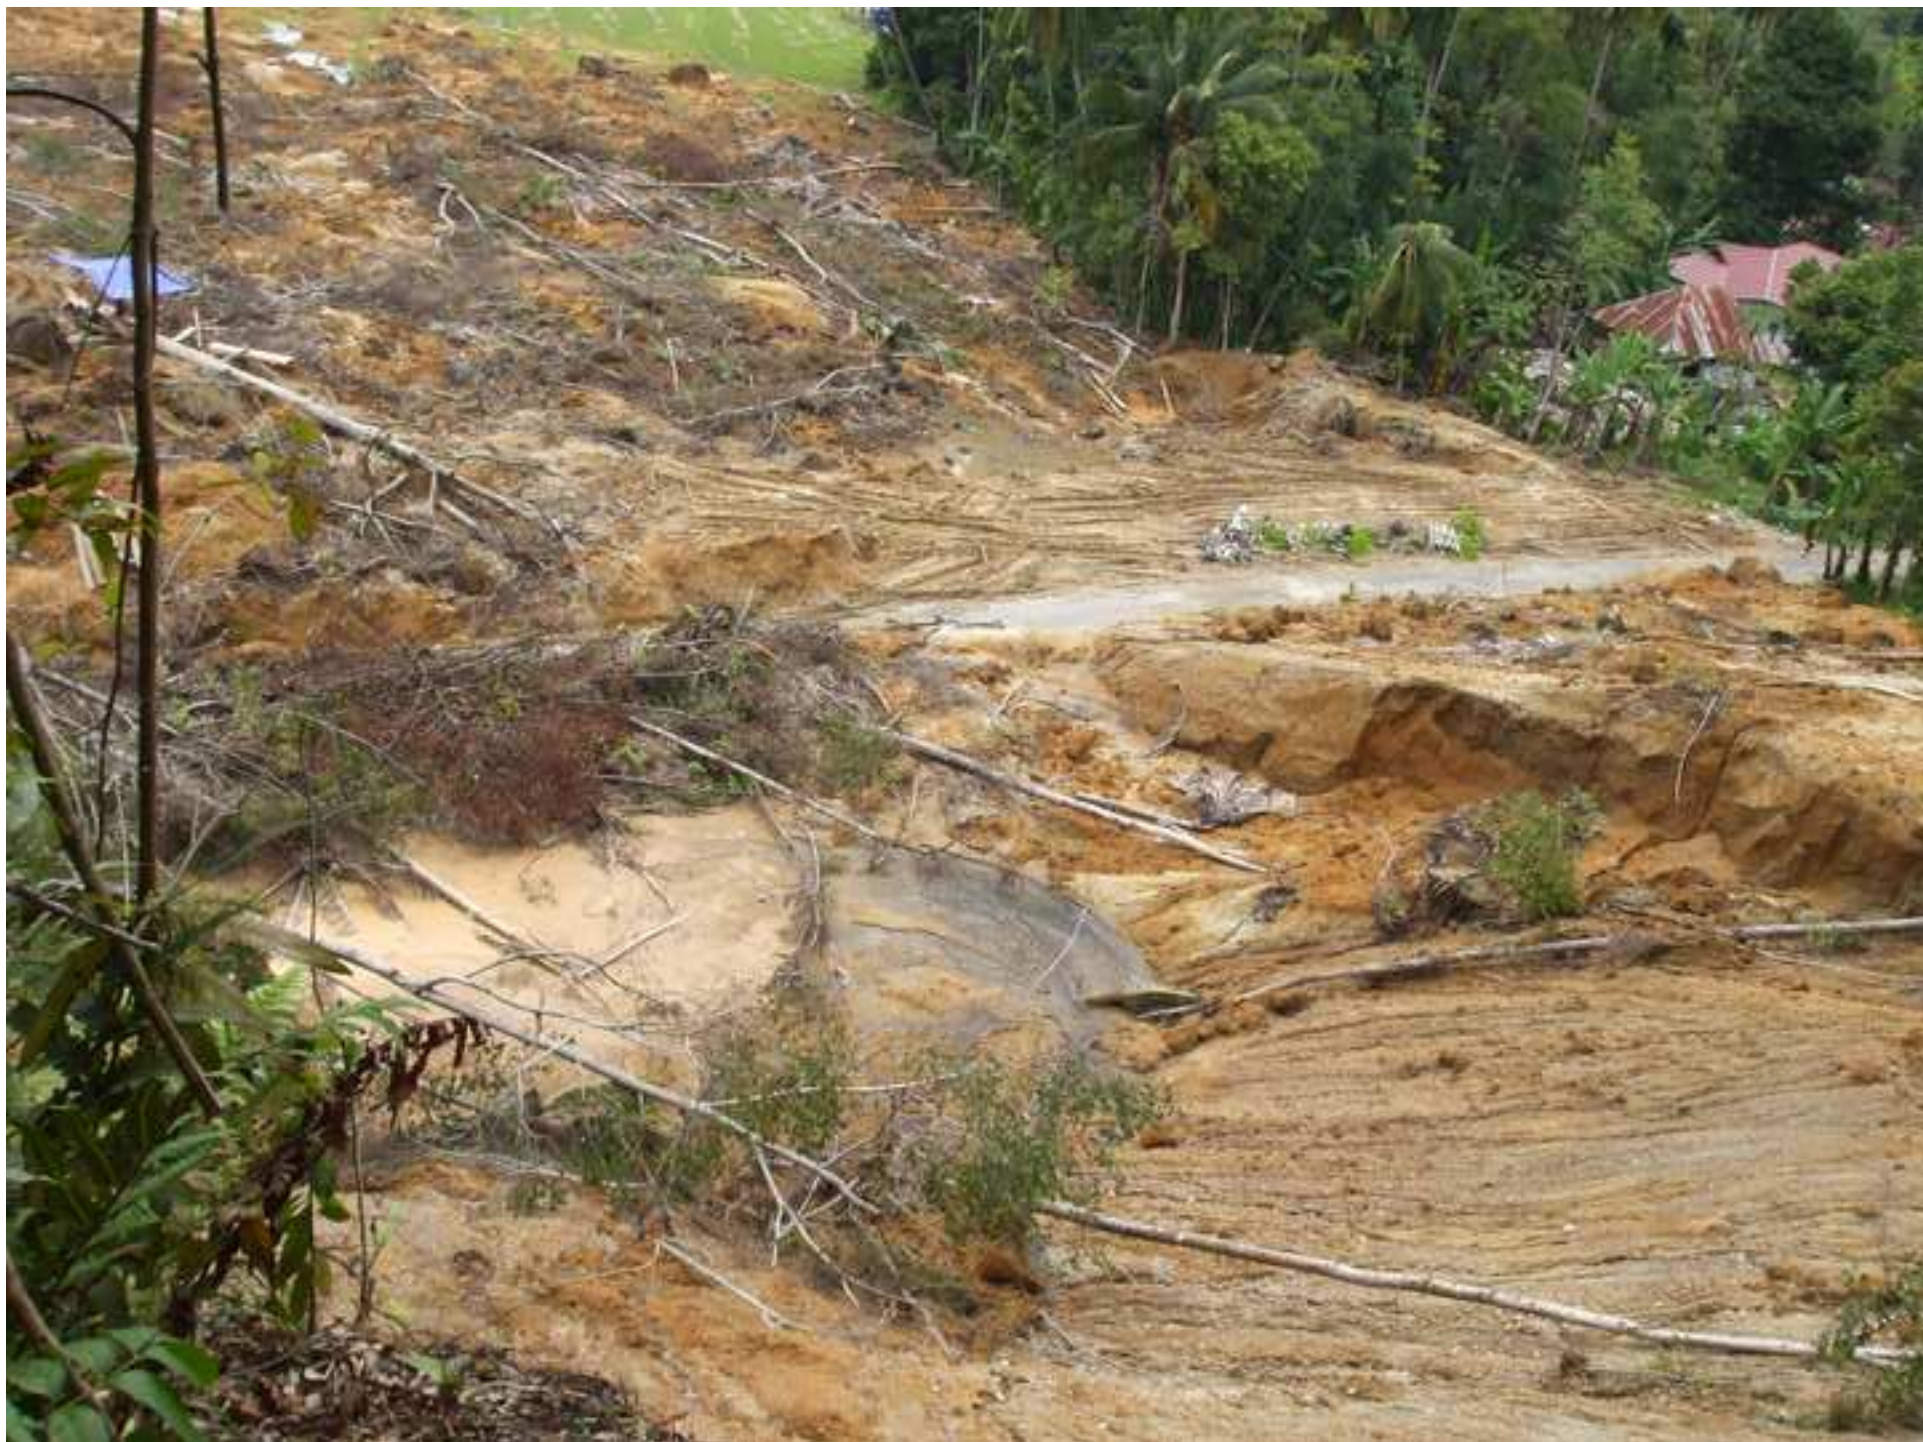
Figure 5
[Click here to download high resolution image](#)

Fig. 5 View of a slip-circle landslide failure at Pulau Air Village (seen from the crest of the landslide)

At the time of the reconnaissance, Landslide 1 (see Fig. 5) at Pulau Air village was accessible via car. The height of the scarp and runoff distance was measured as 65 m and 230 m respectively. The characteristics of the landslide measured using GPS receivers and laser measurement devices were as follows: elevation of scarp (247 m), elevation of base of scarp (182 m), landslide length (230 m), maximum landslide width (120 m), average landslide thickness

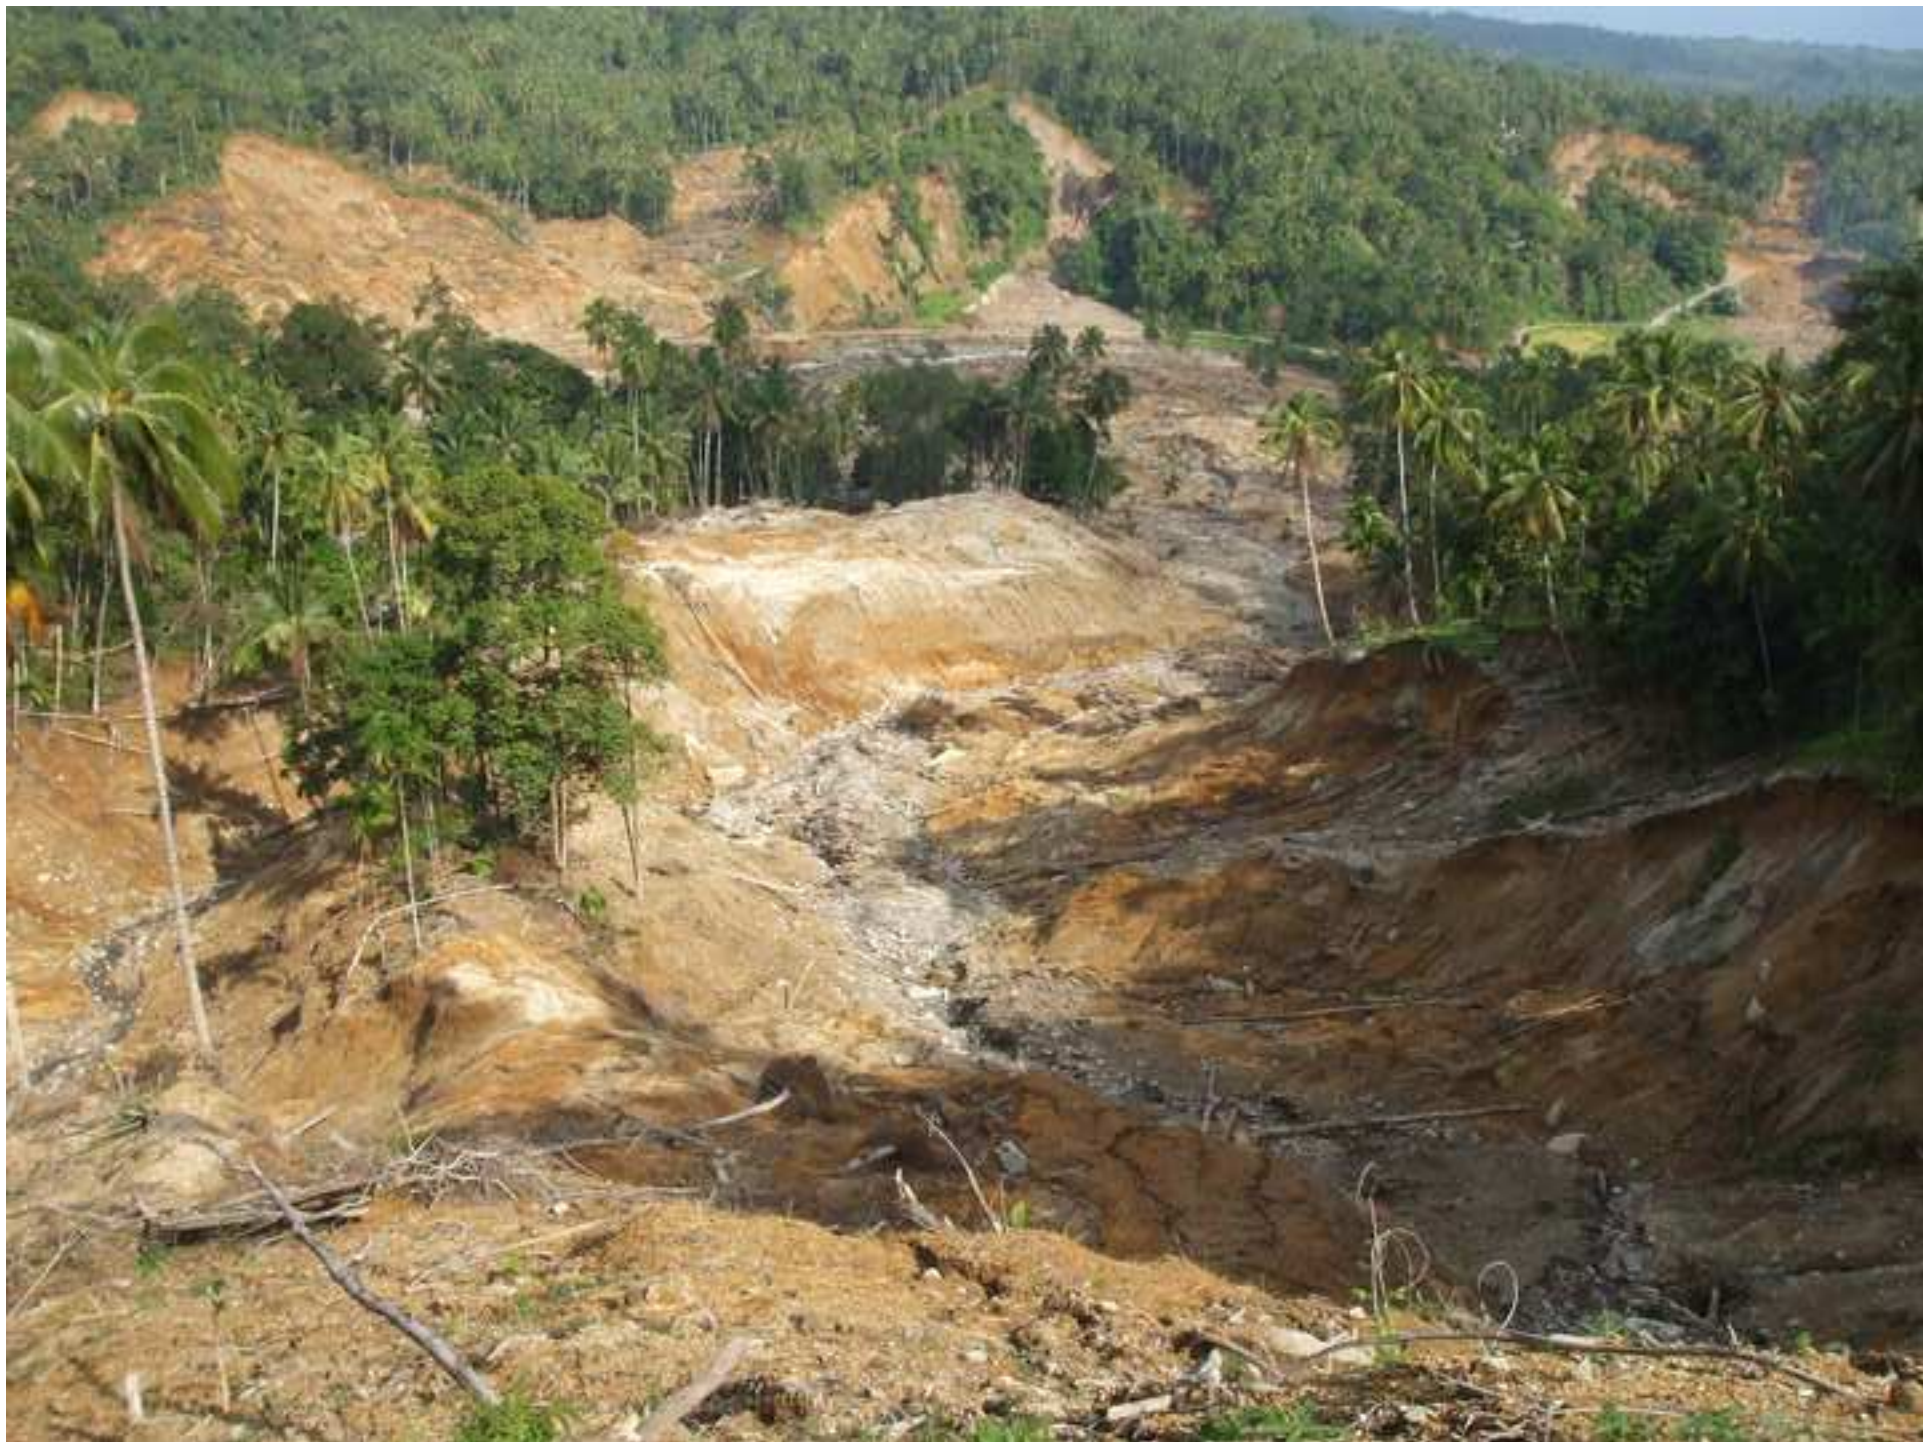
Figure 6
[Click here to download high resolution image](#)

Fig. 6 View of an infinite slope landslide failure at Cumanak Village from near the summit of the landslide

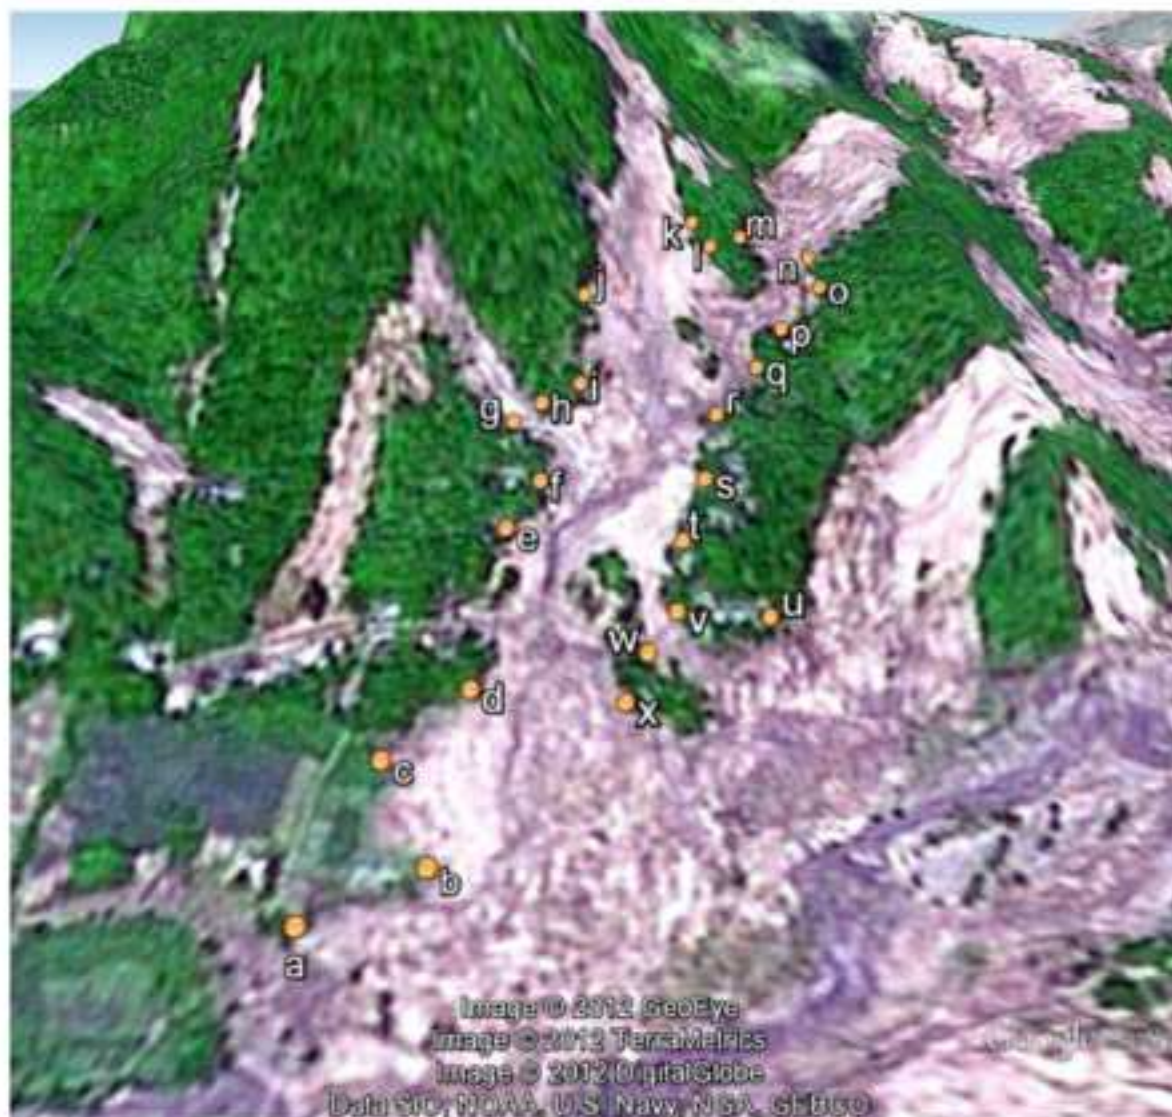
Figure 7b
[Click here to download high resolution image](#)

(b) Landslide II ($0^{\circ}29'54.64''\text{S}$ $100^{\circ}14'26.59''\text{E}$)

Fig. 7 Locations of landslide boundary points, superimposed on SPOT-5 image acquired by CRISP NUS with Google™ Earth's terrain background feature

The data in Table 2 shows the measurements for part of Landslide *II* in Fig. 7b. Despite the larger extent of Landslide *II* in comparison to Landslide *I*, the maximum difference with RMS in the longitude and latitude of Landslide *II* (approximately 0.24 arc seconds or 7.3 m) obtained from the SPOT-5 imagery and the GPS survey records is similar to Landslide *I*. This indicates that the accuracy of the coordinates from the satellite imagery is independent of the scale of the landslide.

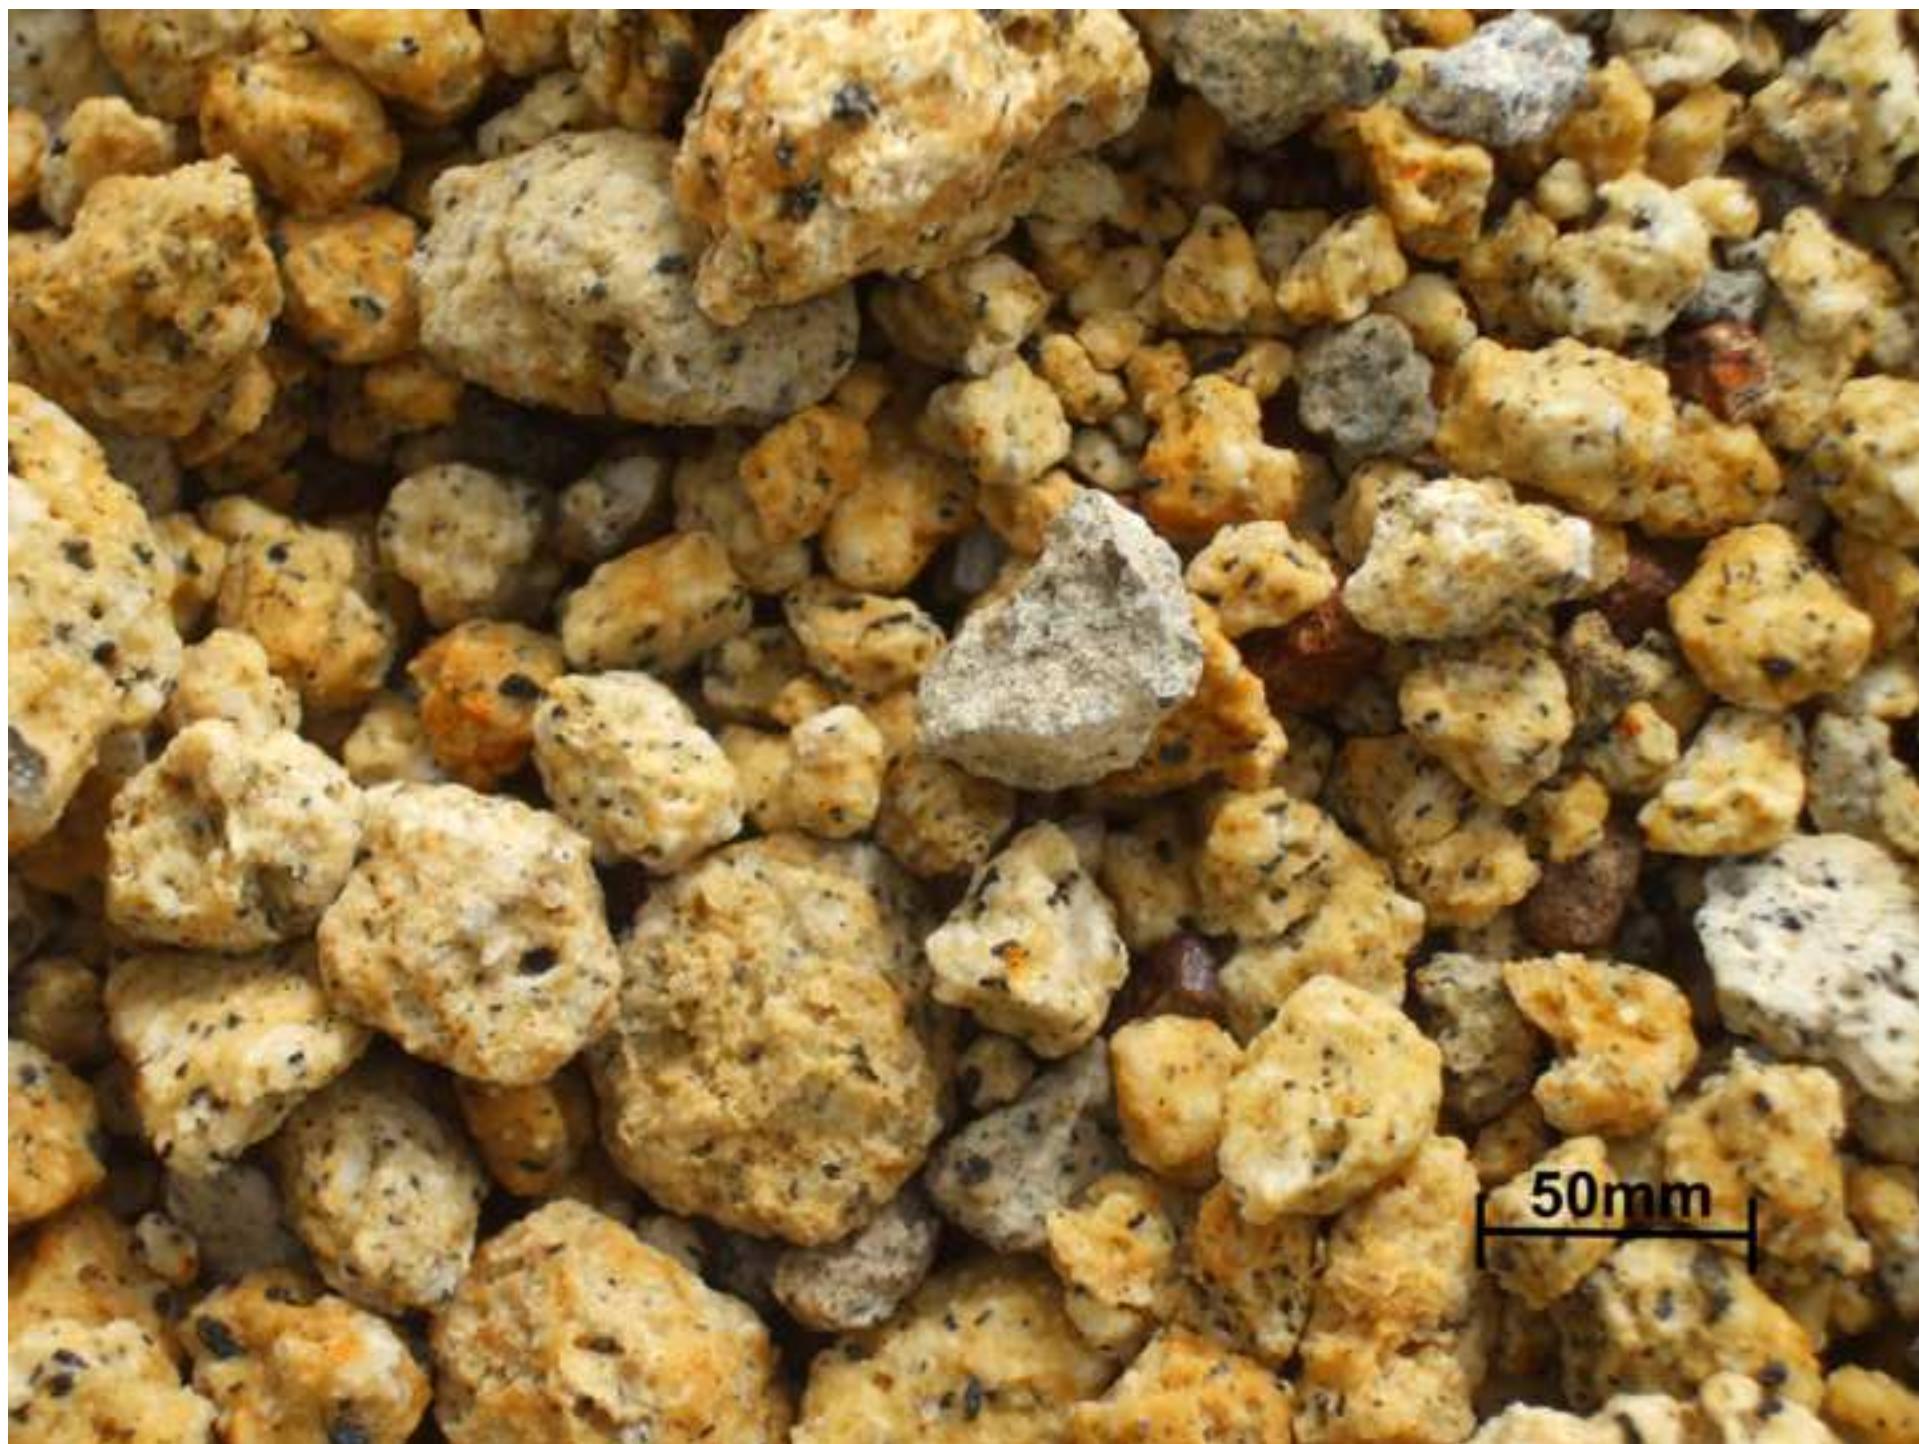
Figure 8
[Click here to download high resolution image](#)

Fig. 8 Weathered pumice observed on the surface of the investigated landslide debris

During the survey, much of the landslide debris runoff was found to be predominantly cohesionless soil, with considerable contents of silt, sand and pumice aggregates. Pumice aggregates as shown in Fig. 8 generally have little cohesive strength and derive most of the shear strength from their high coefficient of friction $[\tan\Phi]$ due to angularity and interlocking of individual particle. The lower and upper range values of friction angle of the upper layer of the soil considered in the model are therefore 30° and 50° , which are typical for cohesionless soil. Given the dense vegetation of the slopes and the cohesionless nature of the upper soil layer in general, the input lower and upper bound values of both the root and soil cohesions $[C_r \text{ and } C_s \text{ respectively}]$ are assumed as 0 kPa and 15 kPa. Based on Eq. 4, the dimensionless cohesion $[C]$ computed is between 0 and 0.85. The saturated soil density $[\rho_s]$ is assumed as 1500 kg/m^3 , which is at the lower range of typical values for cohesionless soil, considering the presence of lightweight pumice aggregates.

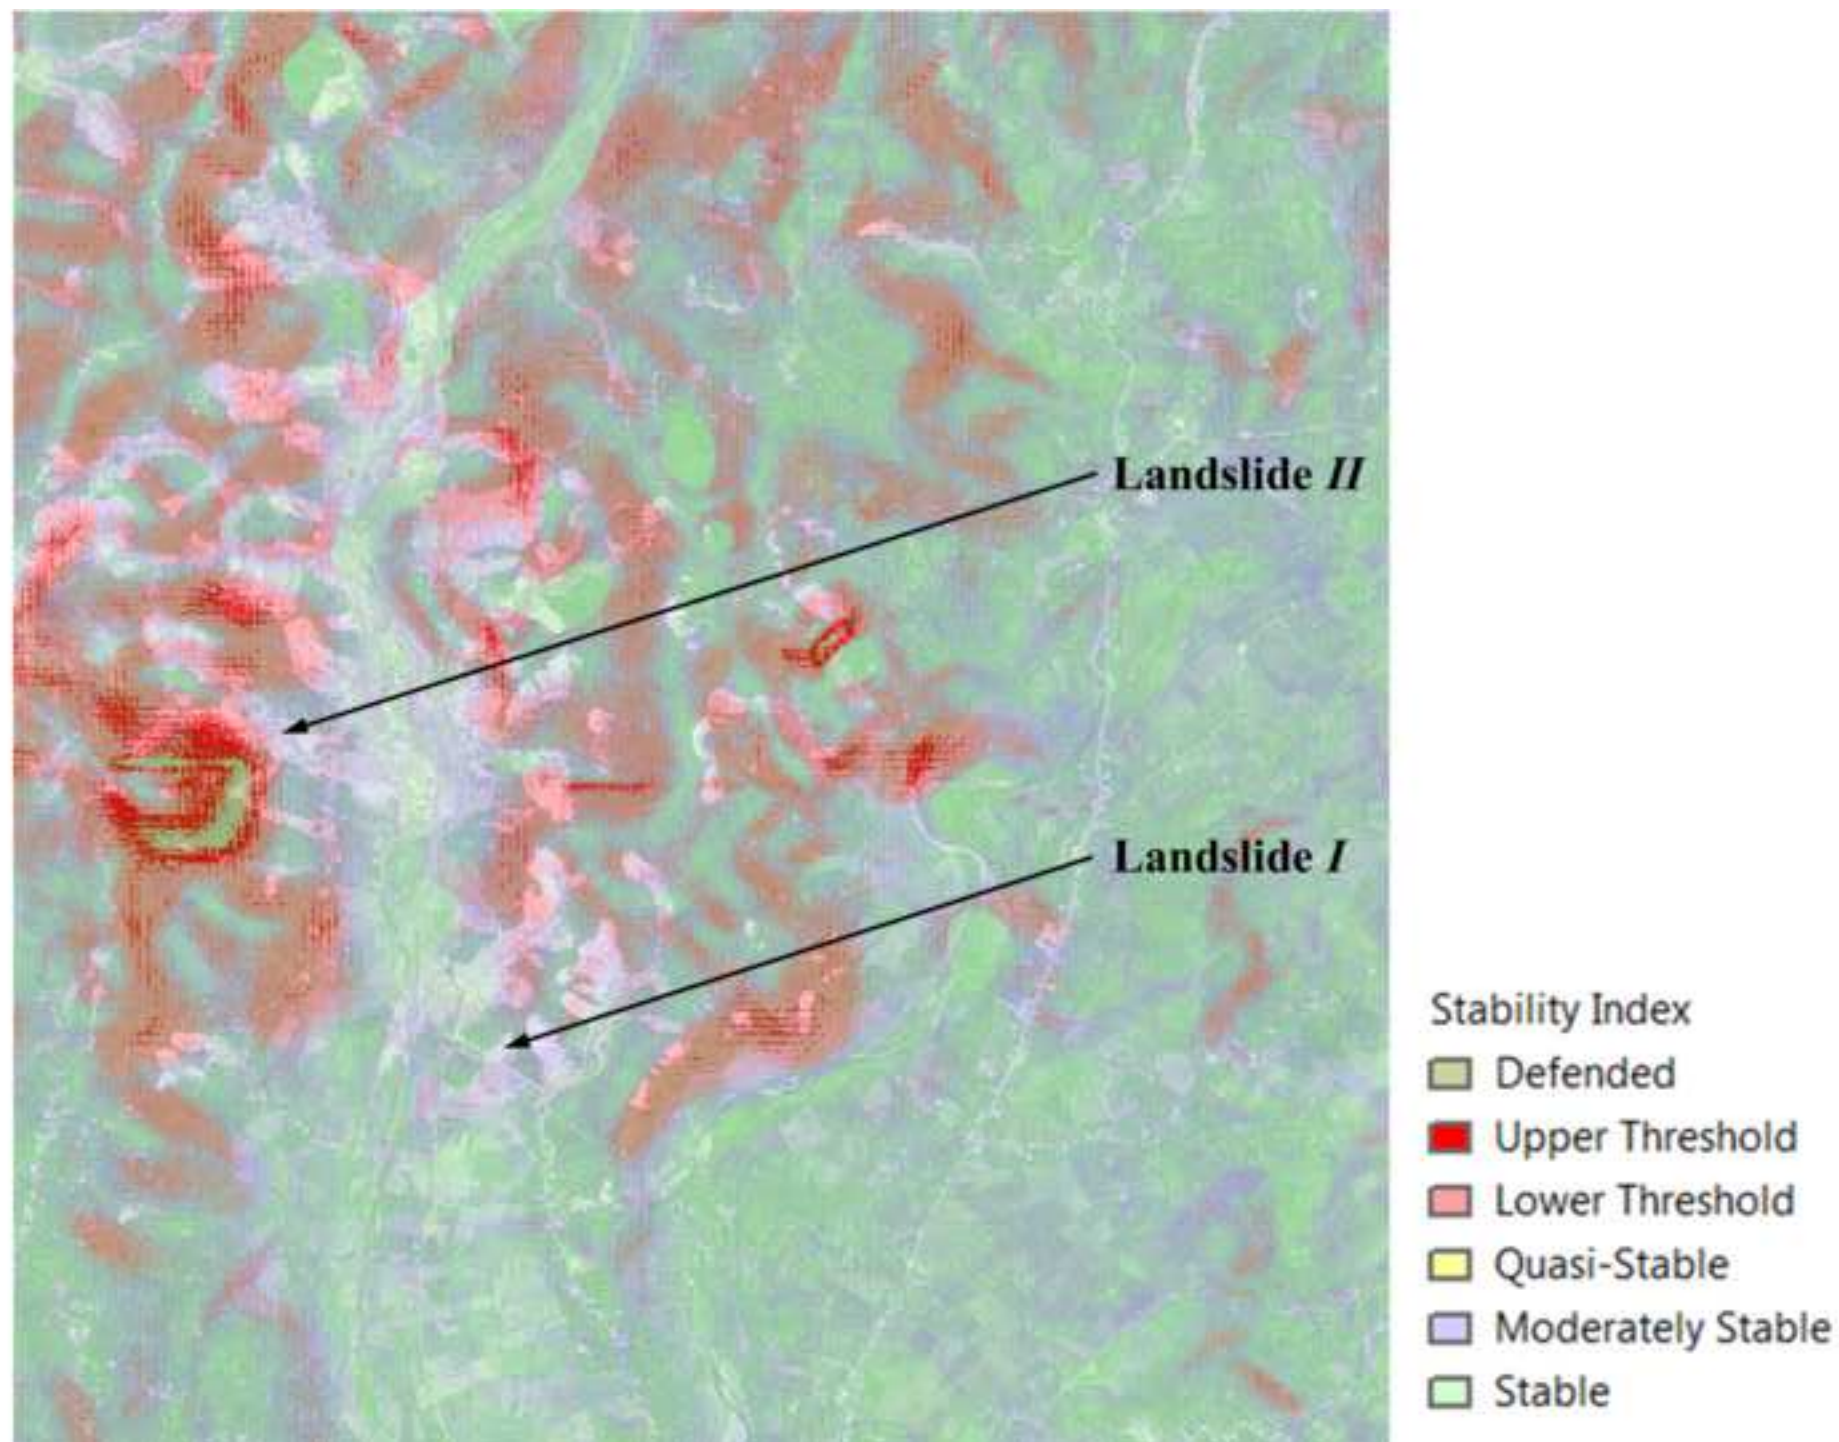
Figure 10
[Click here to download high resolution image](#)

Fig. 10 Stability index (SI) map overlaid with SPOT-5 satellite image from CRISP NUS

Using the above input values of cohesion $[C]$, topographic relative wetness $[T/R]$, friction angle $[\Phi]$ and saturated soil density $[\rho_s]$, the contribution area and stability index maps were produced as shown in Figs. 9 and 10.

< 1). At areas in the SI map where there are no significant red zones (especially at the right hand side of Fig. 10), large landslides are not visible in the overlaid satellite image. The combination of analysis from contribution streams (Fig. 9) and slope stability analysis (Fig. 10) would give a much accurate identification of areas susceptible to landslide. Locations of Landslides *I* and *II* are indicated in Figs. 9 and 10. Landslide *II* is sited near a high contribution stream (Fig. 9) and unstable slope area (Fig. 10) which substantiates the reliability of the analysis to identify potential areas susceptible to landslides. In the case of Landslide *I*, it is not located near high contribution streams (dark blue lines) and very unstable slope area (dark red zones) as shown in Figs. 9 and 10 respectively. Hence, its occurrence was not expected based on the analysis. On the other hand, there are occasions where areas with low SI values (indicated by dark red zones) did not fail in this earthquake event, implying that the produced SI map is conservative in those areas. The slight inconsistencies in identifying landslide susceptible areas could possibly be due to three reasons: 1) the inaccuracy of elevation interpolation in the resampled DEM at these areas, 2) variability of soil condition, or 3) the effect of strong earthquake leading to variation in reduction of slope stability. High pore water pressure generation (i.e. soil liquefaction) near the soil surface due to the earthquake shaking could have enhanced the landslide occurrence probability. The presence of lightweight pumice aggregates might have also aggravated the problem. Based on field observations, these pumice deposits appeared not extensively cemented but only undergone some compaction under their own weight. In addition, the porous nature of the pumice aggregates allowed rainwater to infiltrate through this upper layer of soil, but the rainwater could not infiltrate further into the deeper, low permeability layers which might have created a film of water beneath the pumice layer where the potential slip failure occurred. High velocity landslide flow could therefore be triggered instantly at regions of near-unstable soil when sheared by the earthquake shaking. Nevertheless, the analysis conducted was capable of identifying large scale landslides which are more likely to result in high property and human losses. Based on the landslide hazard map in Fig. 2, the region is located in the moderate risk zone. However, the occurrence of massive landslides in this region has portrayed that the map is not sufficient. The analysis carried out in this paper has shown to be more capable of identifying areas of high risk of landslides and at a much detailed scale. Despite the success of the analysis, further enhancement to the existing methodology of this analysis to better reflect the effects of earthquake is desirable in the future. Given the frequent occurrence of large earthquakes accompanied with the risk of landslides due to heavy tropical rainfall intensity and soil condition in West Sumatra, it is imperative that the region be reviewed for potential combined effects of rainfall and earthquake which could possibly lead to a revision of the existing landslide risk in some areas of the affected region.
